潮湿环境下露天石质文物盐致劣化机理

摘要:为研究可溶盐侵蚀导致的潮湿环境下露天石窟寺的劣化机理。以重庆石佛寺遗址摩崖造像为研究对象, 采用扫描电子显微镜及能谱仪、X 射线衍射分析仪、X 射线荧光分析仪、离子色谱分析仪、红外热成像仪等多重分析手段对石佛寺遗址摩崖造像表面病害及劣化产物进行科学分析与表征, 厘清了可溶盐主要的种类与来源。在分析数据的基础上, 结合石质文物本体构成与环境变化综合分析, 探讨了潮湿环境下石质文物中可溶盐的作用模式, 为石质文物保护提供了科学依据。

Mechanism of deterioration in open-air stone cultural relics due to salt erosion in humid environments

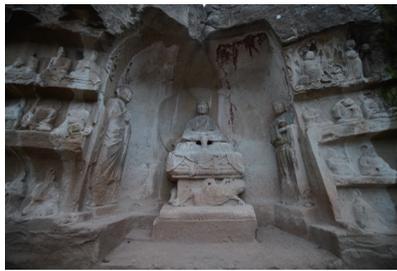
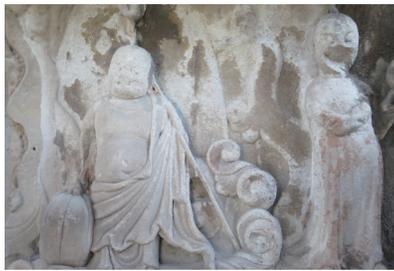
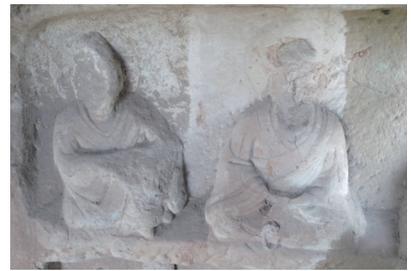
石佛寺遗址摩崖造像千年来由于长期处于露天条件下,受环境中不利因素侵蚀,岩体普遍出现泛盐、粉化、剥落等表面劣化问题。内层岩石继续在环境中劣化,泛盐、粉化等病害进一步发展,在自身重力因素的影响下会逐层剥落(见图 1~6)。

图 1 泛盐

Fig. 1 Salt efflorescence deterioration

图 2 泛盐

Fig. 2 Salt efflorescence deterioration

图 3 泛盐

Fig. 3 Salt efflorescence deterioration

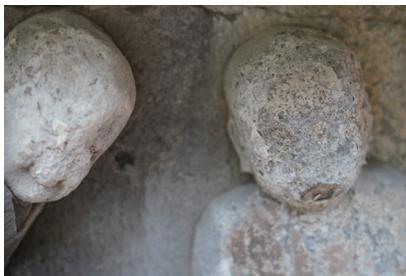
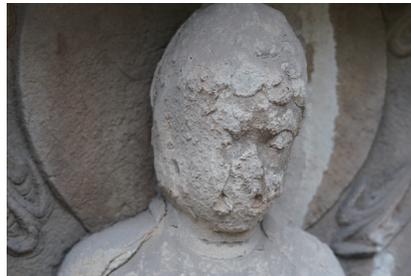
图 4 粉化、剥落

Fig. 4 Chalking and crumbling deterioration

图 5 粉化、剥落

Fig. 5 Chalking and crumbling deterioration

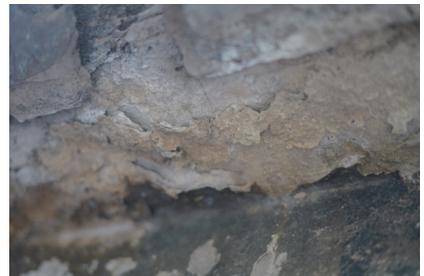
图 6 片状剥落

Fig. 6 Scaling deterioration

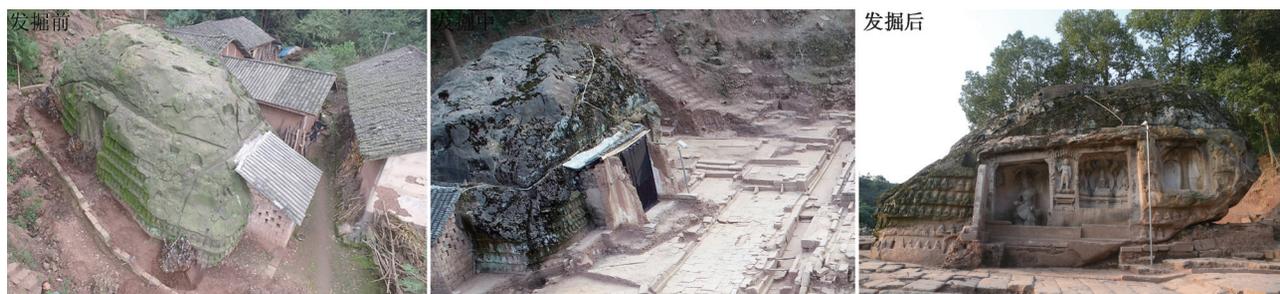
潮湿露天环境下(见图20),石质文物会经受多种不利影响,其中温湿度是影响可溶盐状态变化的关键性因素。采用德国德图公司 testo 175 H1 型温湿度记录仪安放在龕内进行温湿度监测记录,采用德国德图公司 testo 883 型红外热像仪进行温度表征。

图20 摩崖造像赋存环境变化

Fig.20 Impact of environmental changes on the cliff caves
